Haverford Free Library  
Existing Conditions Photographs

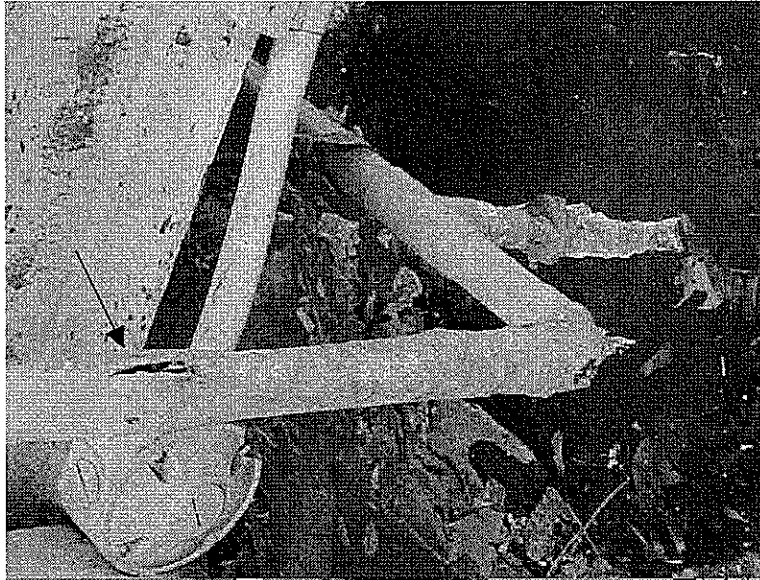
P-1  
Broken water line at cooling  
tower

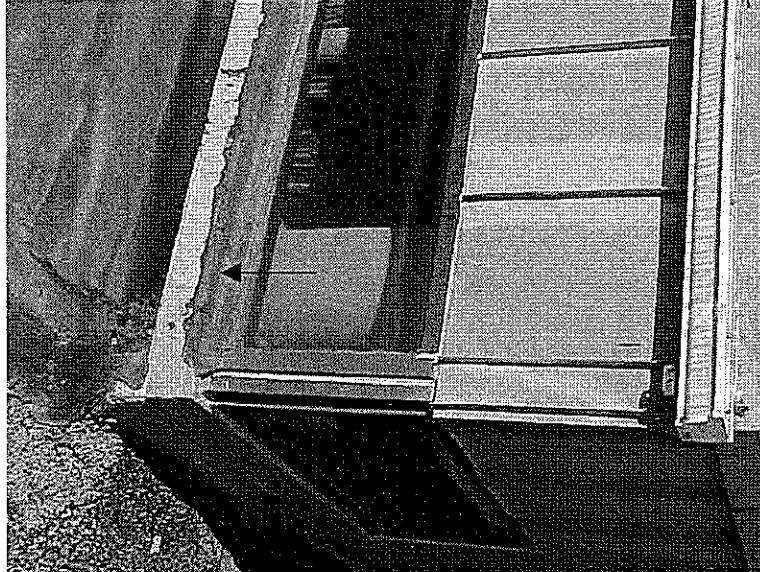
P-2  
Poor flashing at clerestory

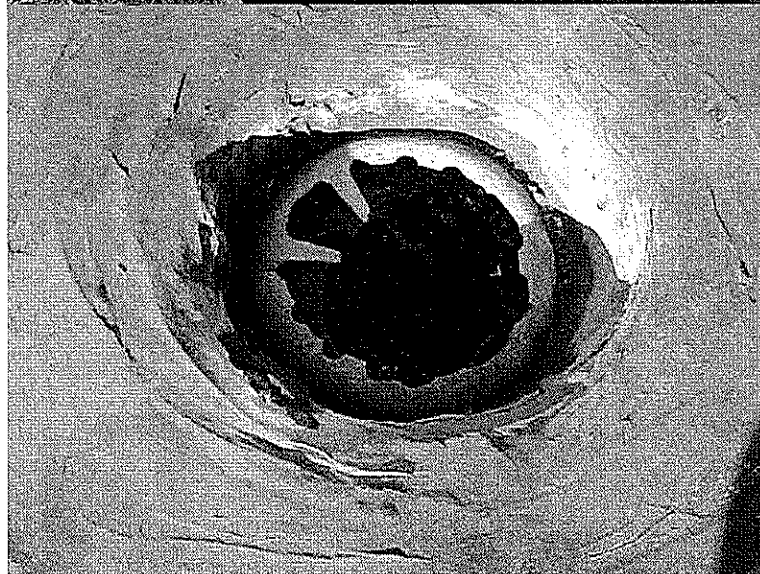
P-3  
Broken drain screen

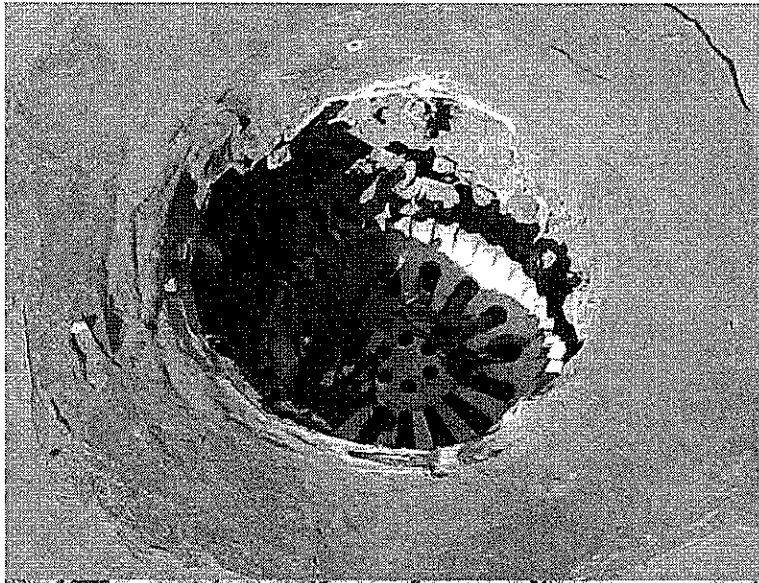
P-4  
Broken drain screen, poor  
flashing

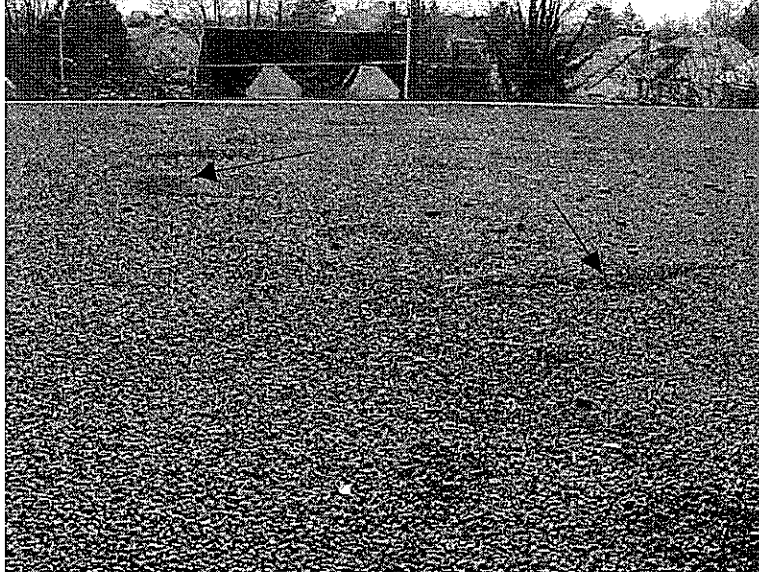
P-5  
Ridging and bubbling of built-up  
roof

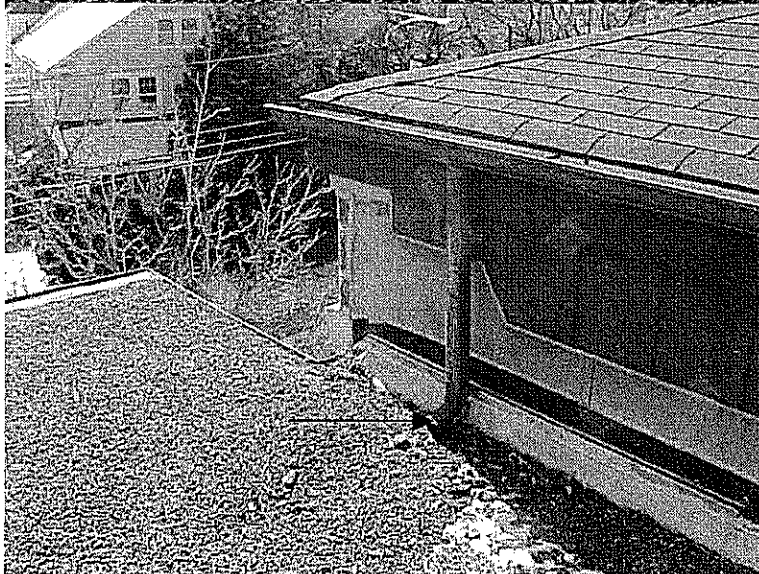
P-6  
Downspout dumping directly onto  
roof

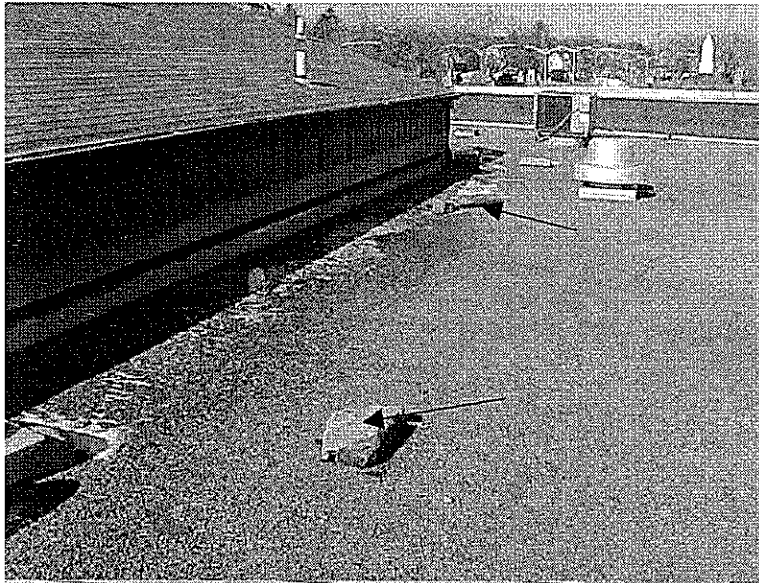
P-7  
Debris on roof

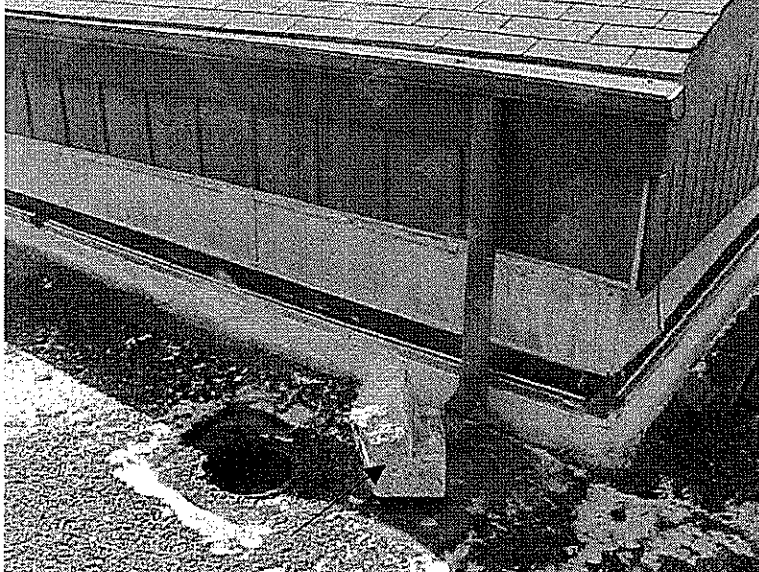
P-8  
Debris blocking  
downspout/drain

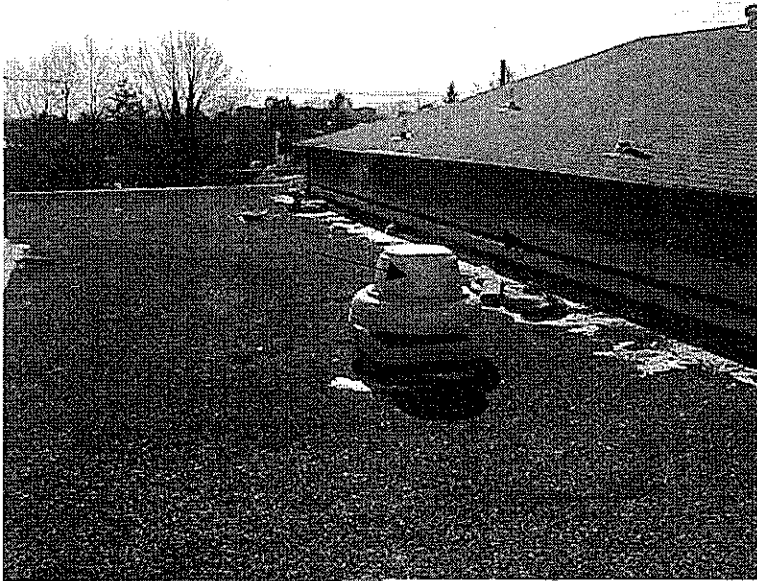
P-11  
Downspout emptying on roof

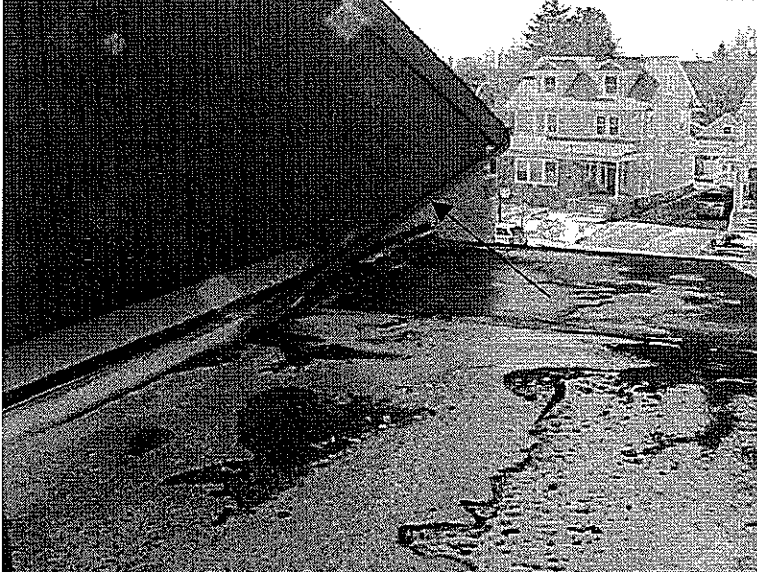
P-12  
Debris on roof (blocking drain)

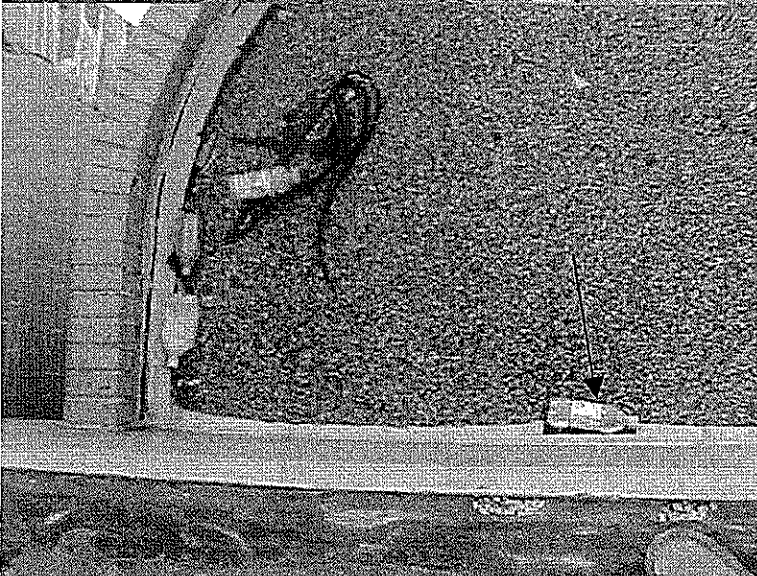
P-13  
Ice on roof indicates ponding  
water

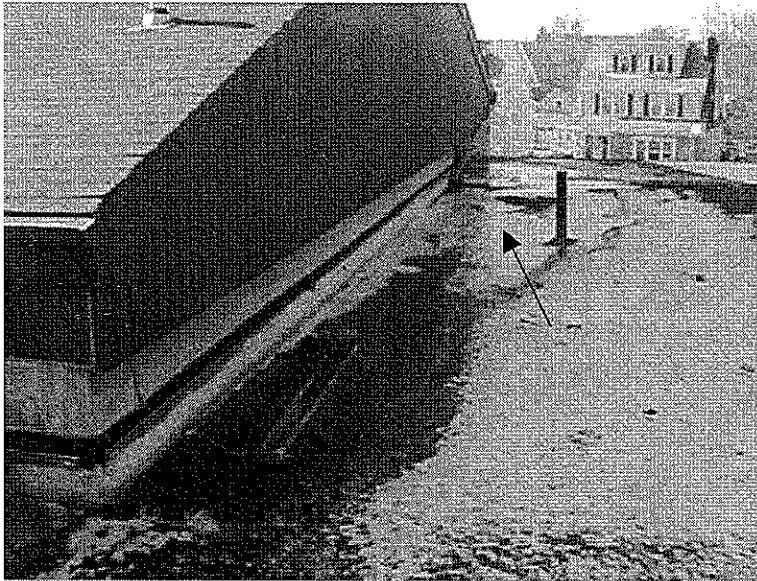
P-14  
Roof repair at cooling tower wall

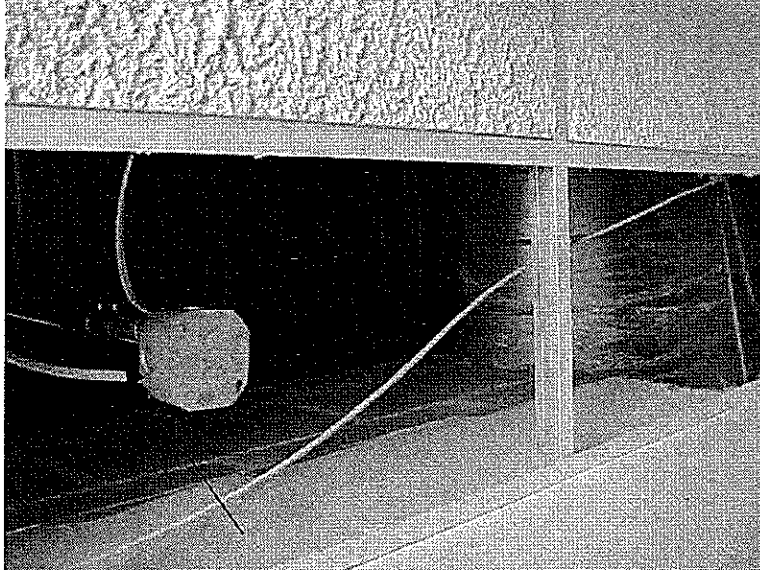
P-24  
Electrical box coming off wall

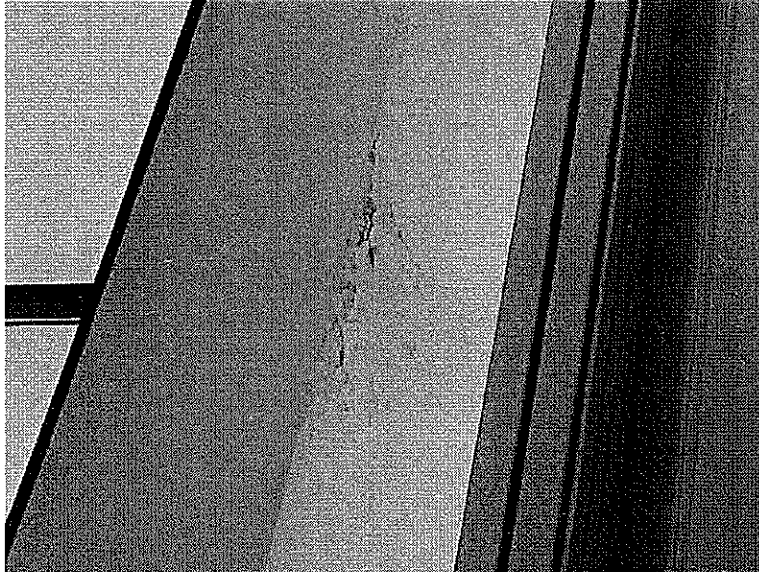
P-30  
Water damage at clerestory roof

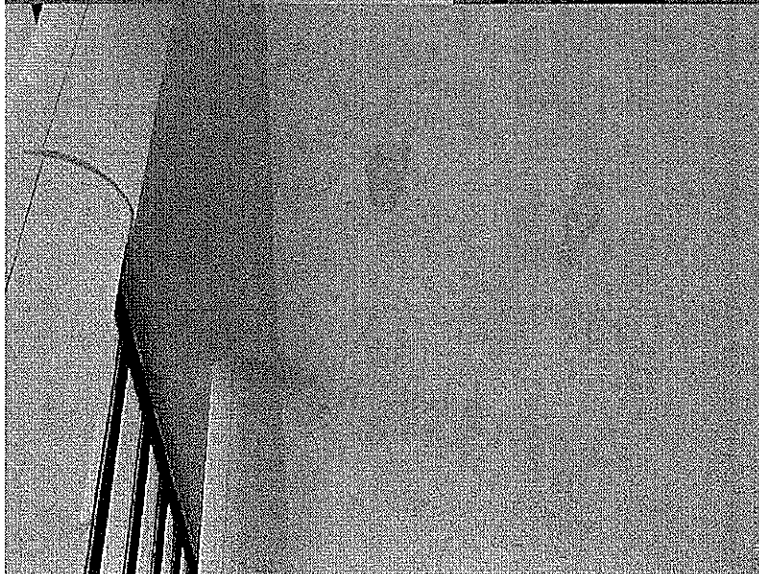
P-31  
Water damage at clerestory  
flashing

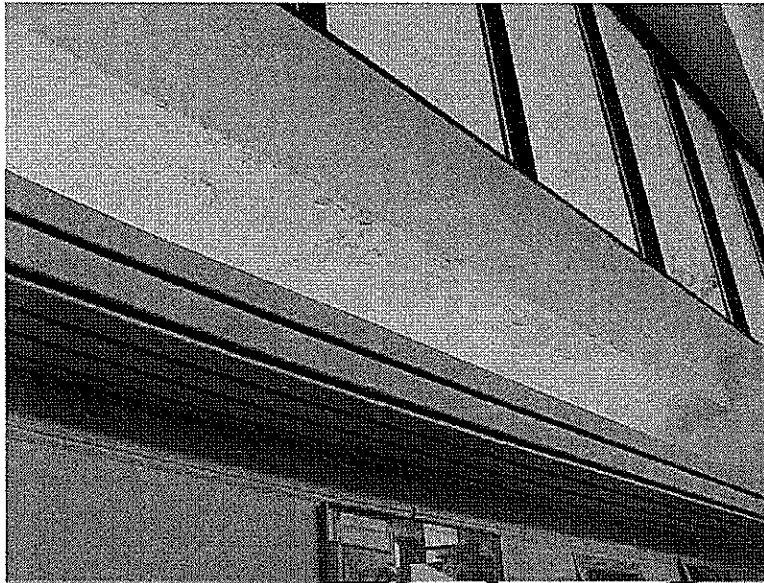
P-32  
Water damage at clerestory  
flashing

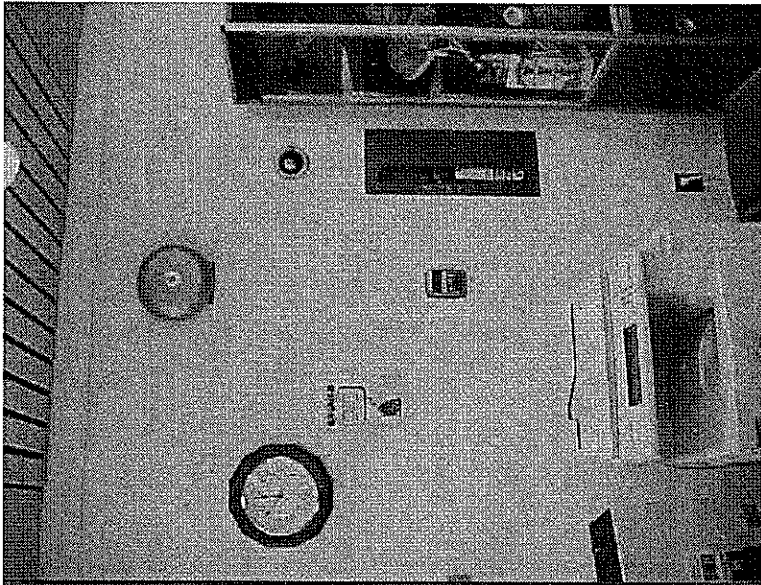
P-35  
Obsolete and inefficient lighting

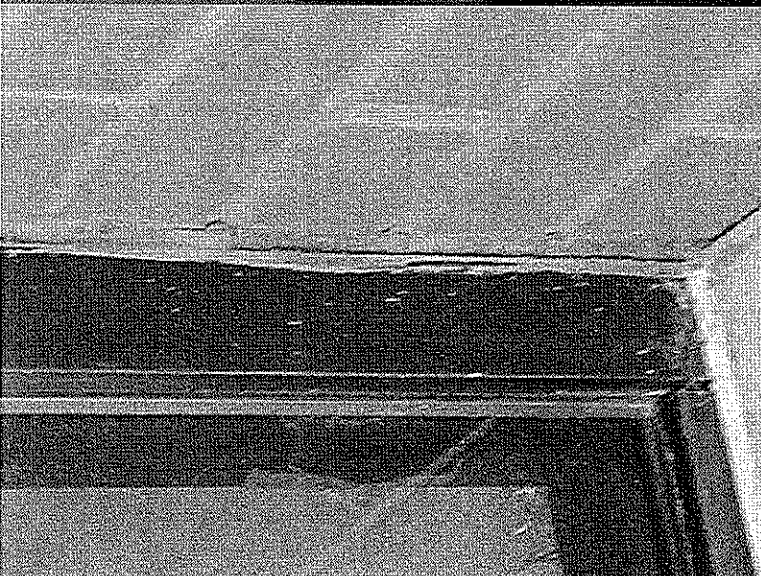
P-37  
Failed sealant

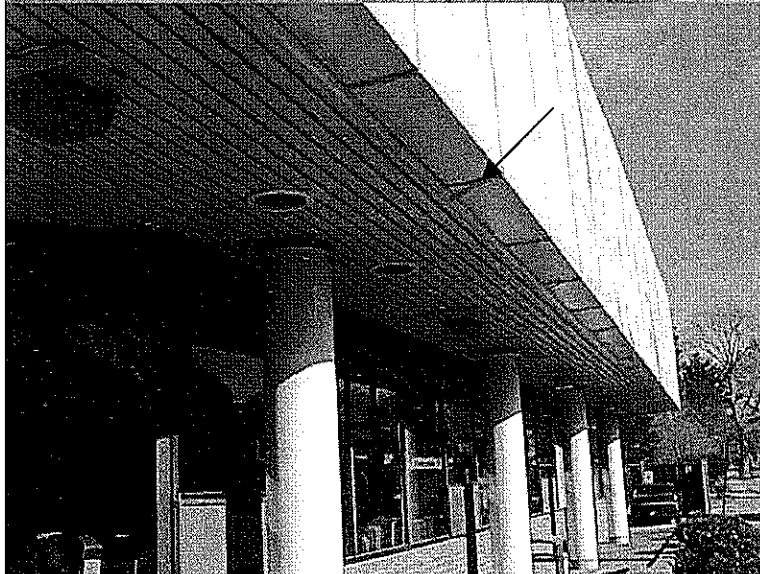
P-43  
Failing sealant

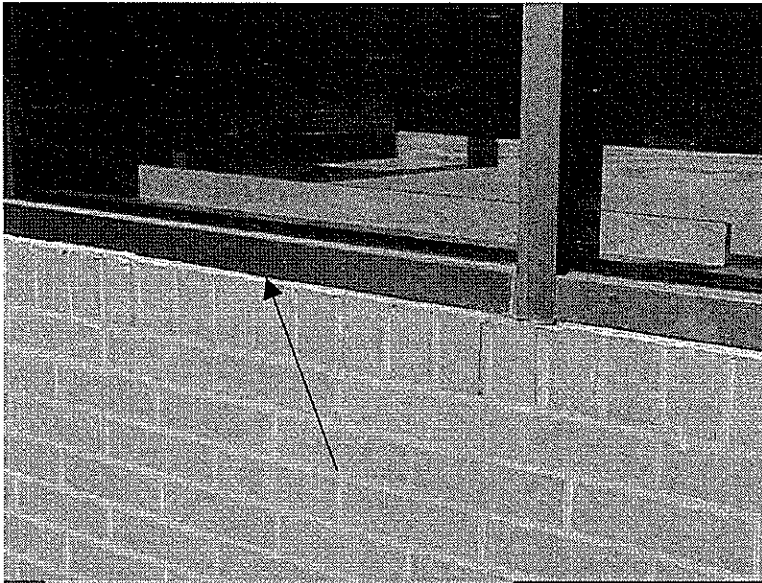
P-44  
Failing panel joints

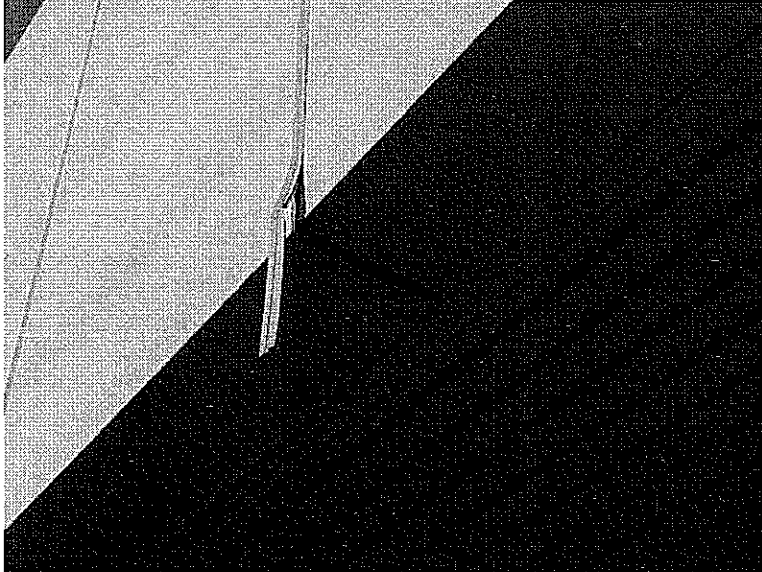
P-45  
Damaged and delaminating  
panels

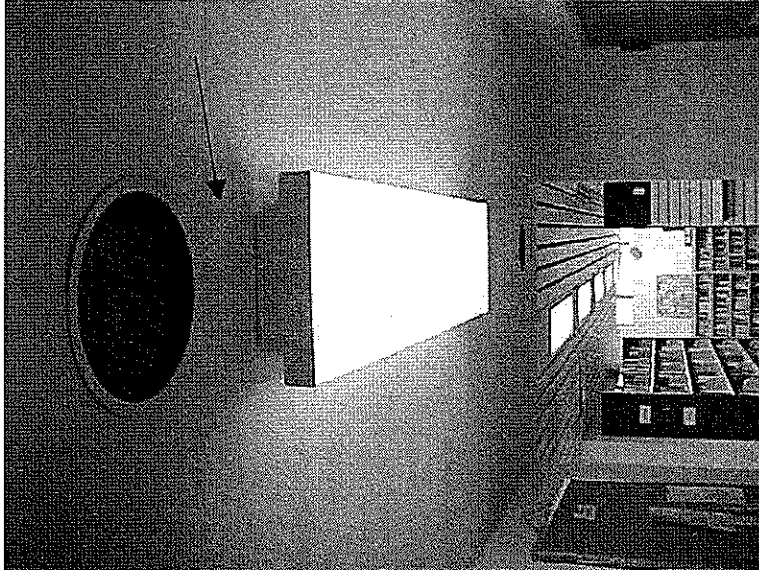
P-48  
Poor space planning and  
utilization

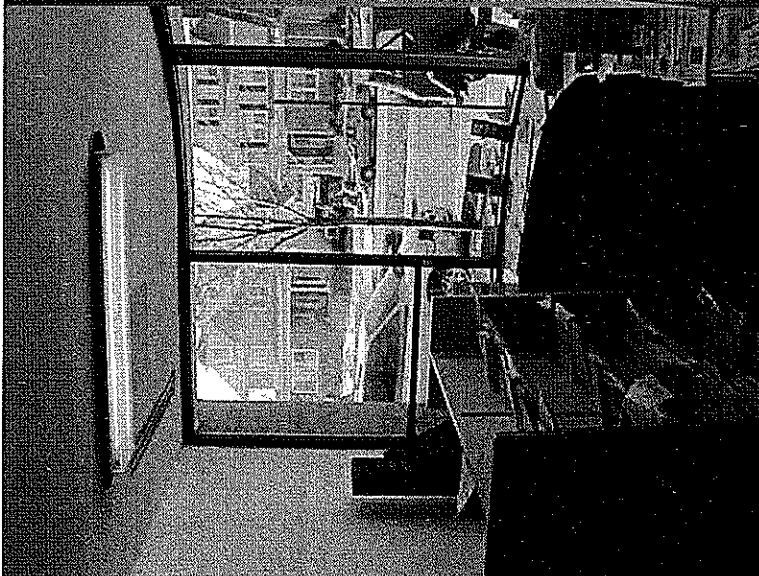
P-49  
Grille kicked in and damaged fin-tubes

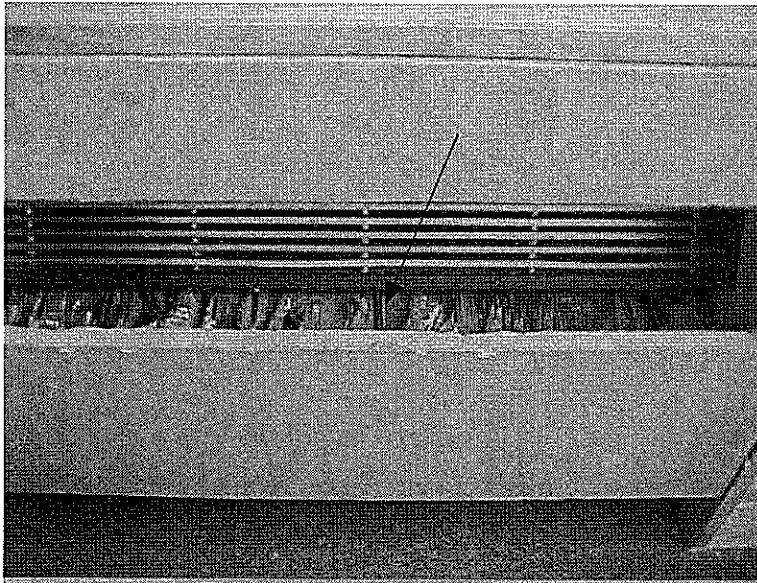
P-50  
Damaged thermostat

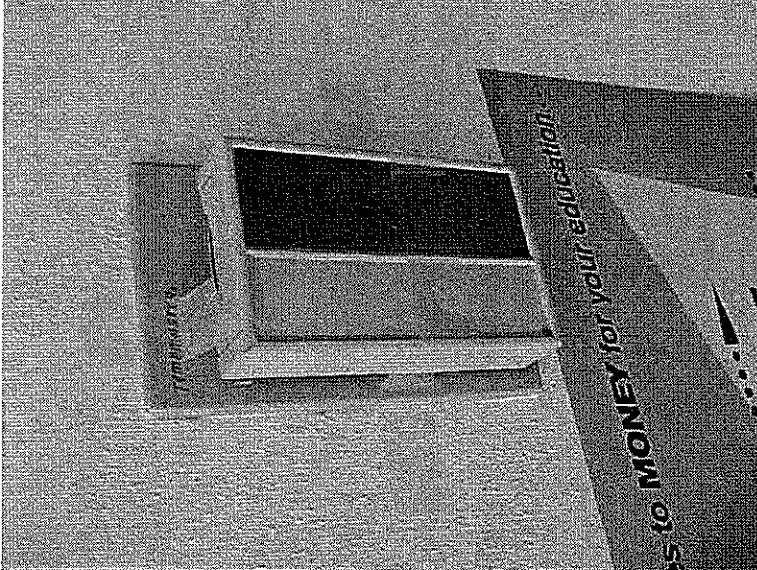
P-51  
Tape over air supply

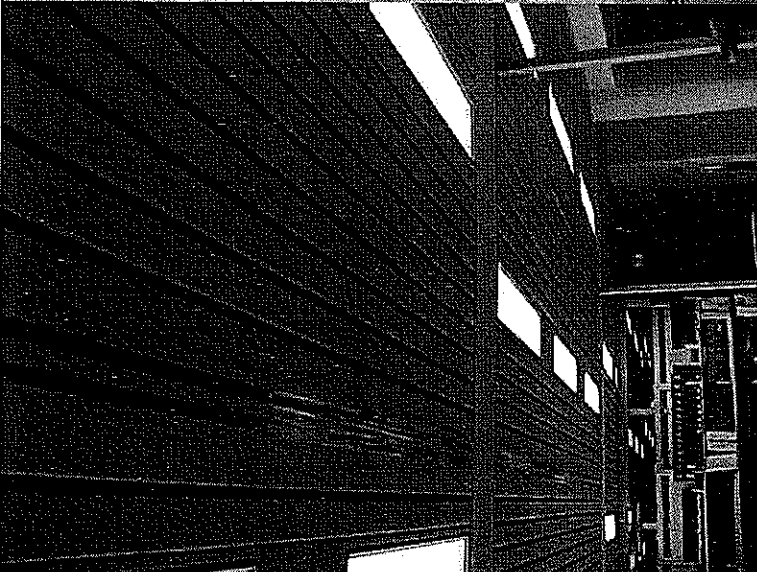
P-52  
Cluttered appearance and poor  
circulation

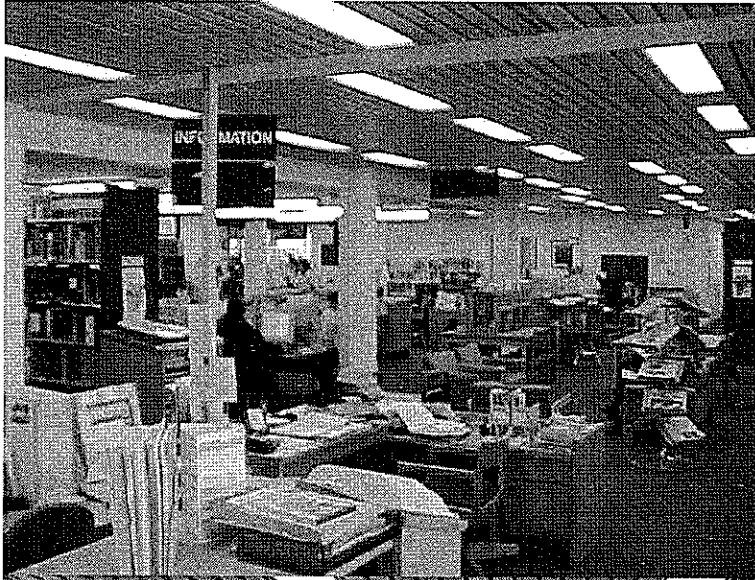
P-53  
Poor lighting and signage

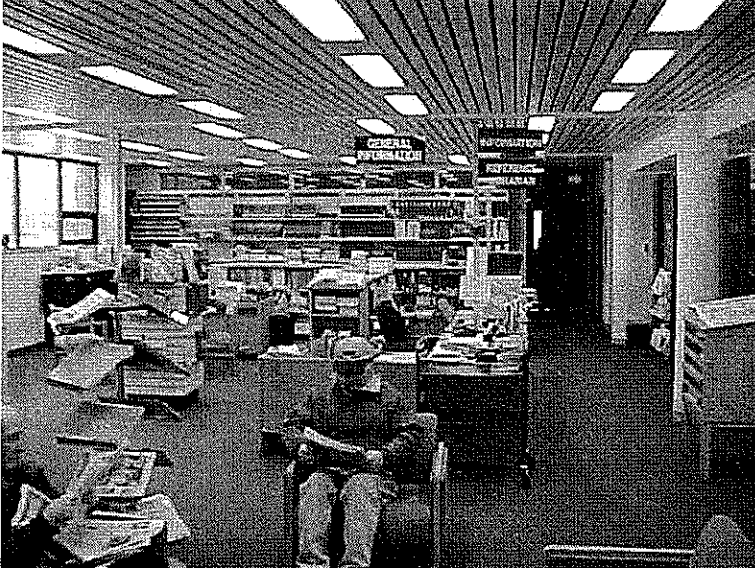
P-54  
Poor lighting and inefficient use  
of space

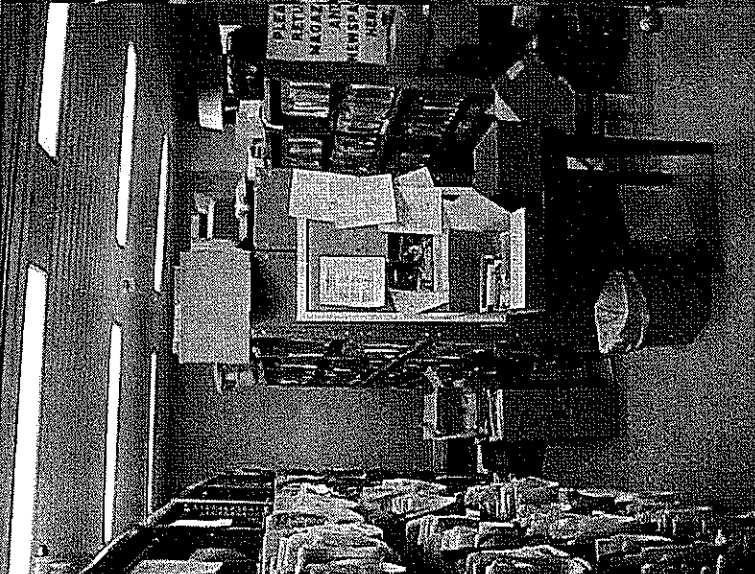
P-55  
Water damage under stair tower  
roof

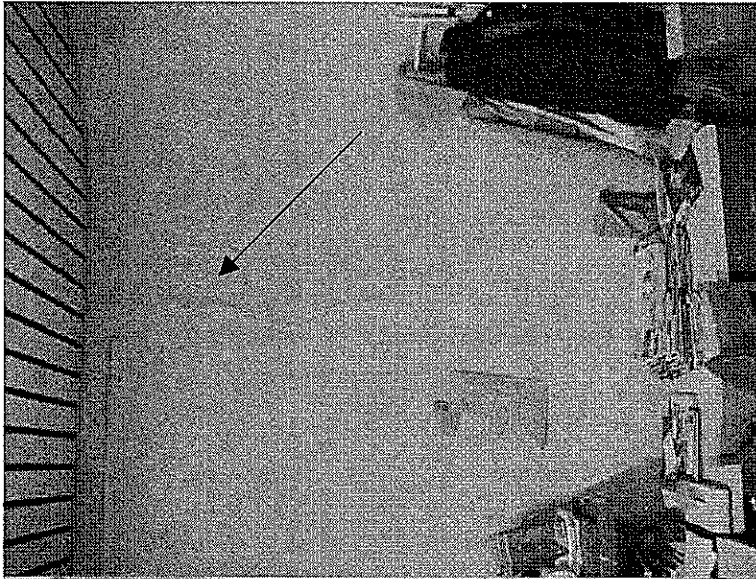
P-56  
Open cable tray on computer table

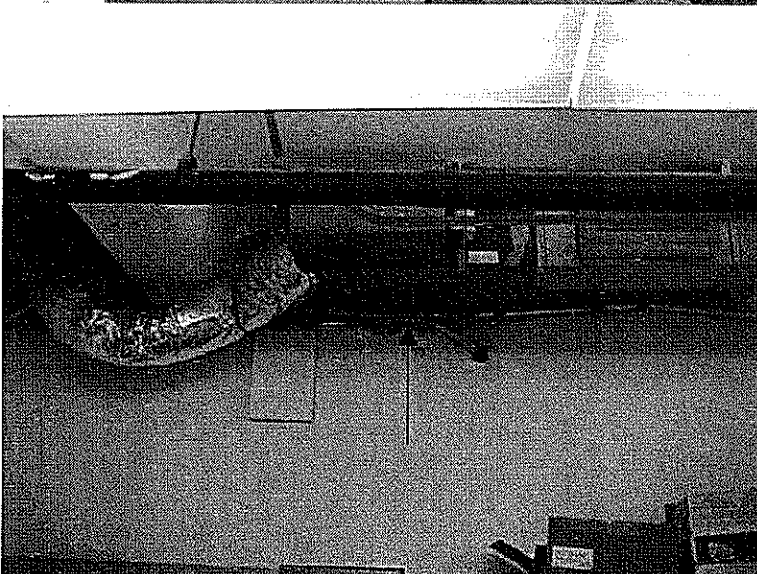
P-61  
Open Junction box and  
unshielded cable

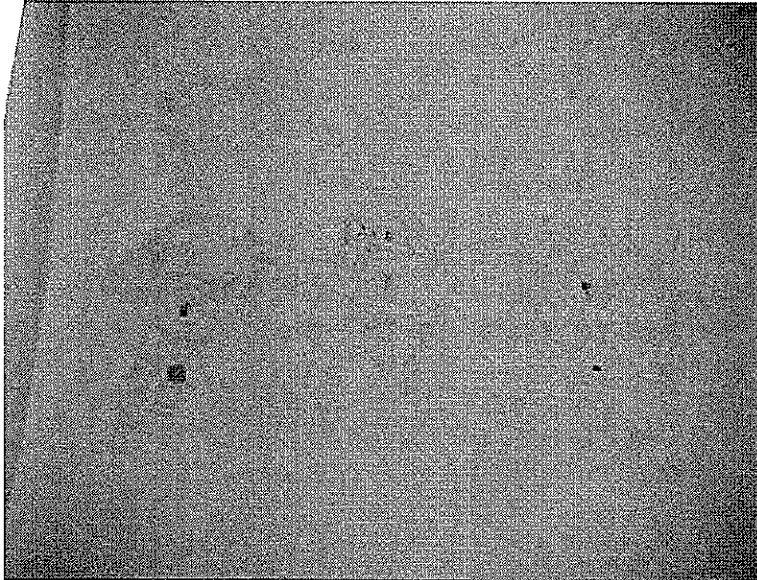
P-65  
Water damage at bottom of east  
stair tower

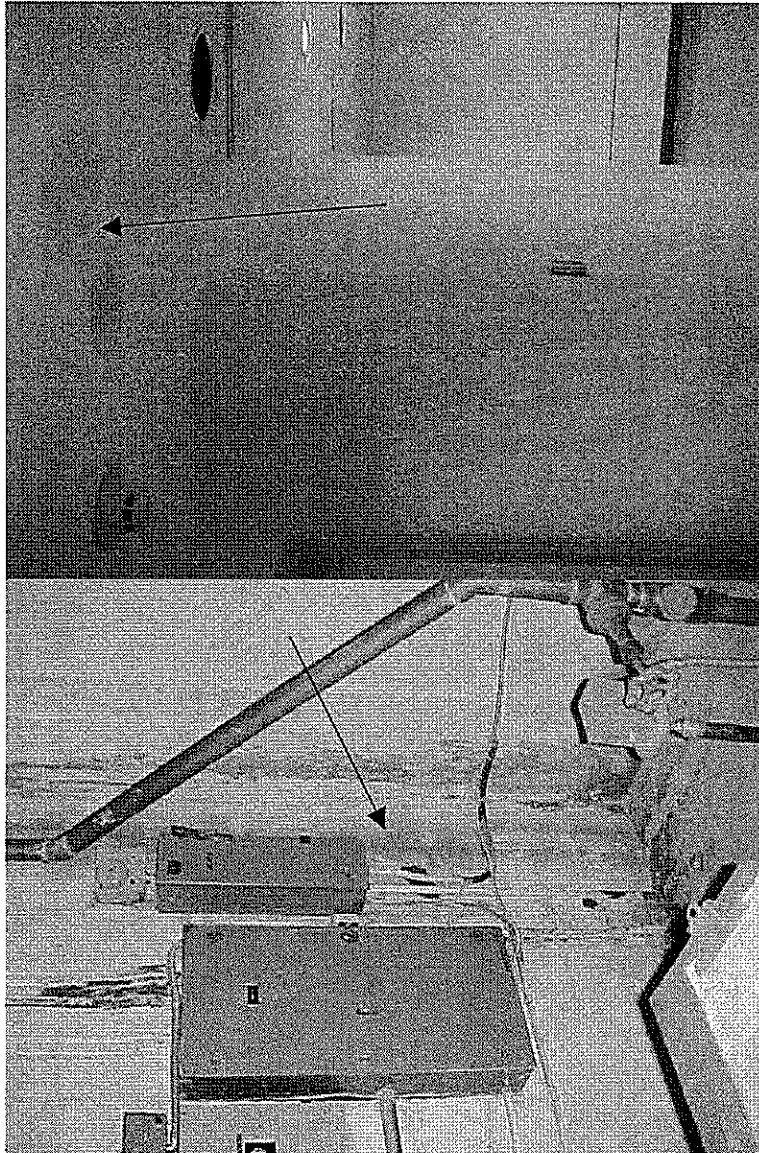
P-68  
Water damage at electrical  
service boxes in SW corner of  
mechanical room

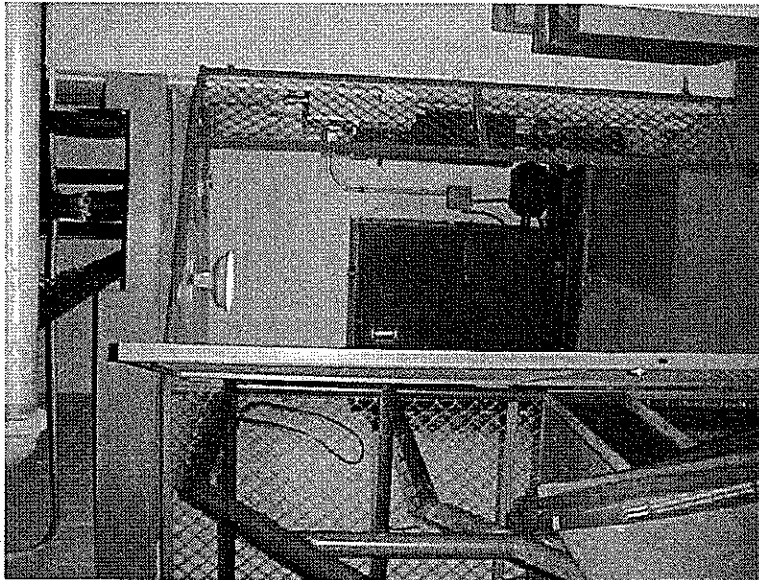
P-68  
No enclosure to elevator  
machine

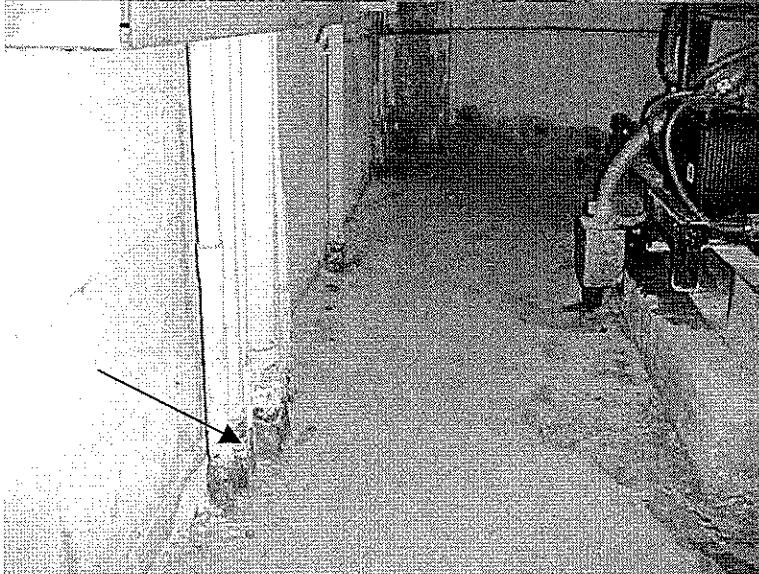
P-69  
Water damage to SW corner of  
mechanical room
